**March 4 - 7, 2018**

## **“Symptoms of failures and solutions to complicated PCB stack ups”**

Ismail Ebrahim, Sandesh K,  
Navneet K Singh, Deepak Sharma  
Intel Corporation

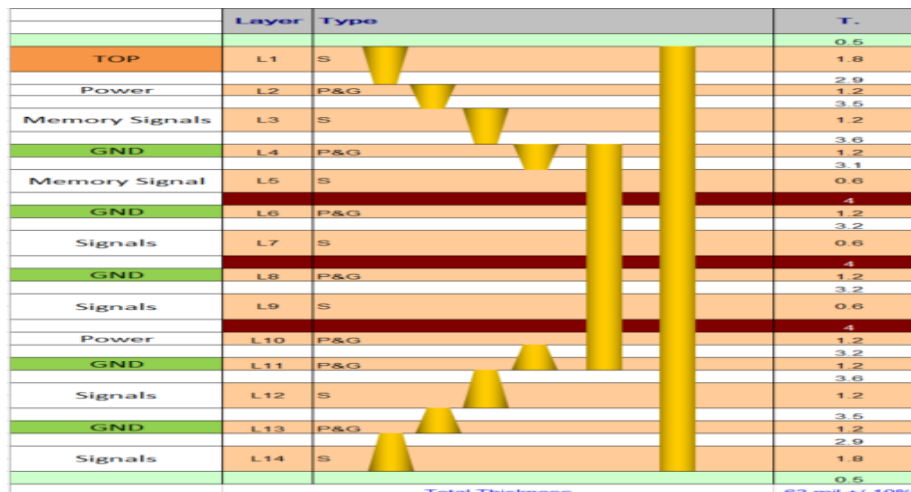
## HDI Stack-up details for Mother Board

- 14 layer HDI 3x3+ stack up
- DDR memory routing on L3, L5 as SOC and DRAM placed on top side and to minimize via stubs.

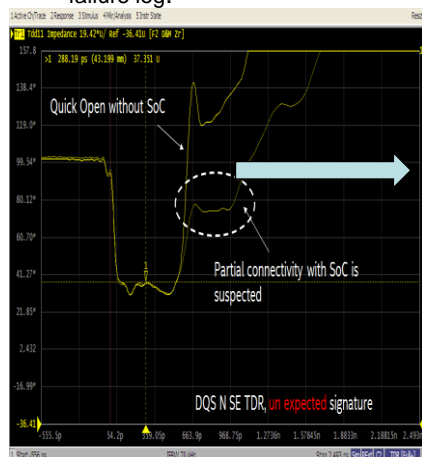
- RC log for one failing system consistently showed failure in write leveling for Channel0 – Byte1.
- Design review of this byte lane on board did not show up any issue.
- Multi meter probing shows proper connections. **but TDR probing on DQS signal however shows high impedance on SOC side implying partial or no connectivity.**
- Below waveform is TDR measurement correlating with the failure log.

- DQS signal for failing byte probed for TDR from DRAM side.
- SOC impedance on higher side (75 ohm v/s 40 ohm expected value for SE measurement). Also, missing C die impact (dip) in the end. → partial or weak DQS connectivity on board.

Series of TDR measurements are made on multiple failing boards and TDR results are correlating with MRC Log.

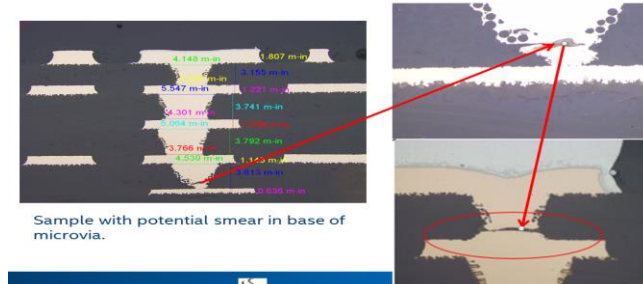
3D X-ray image of via discontinuity

Cross Section image showing hairline crack in u vias.

- ✓ Inconsistent failure signature can imply connectivity or manufacturing issues as potential cause of failure.
- ✓ TDR/TDT can be a handy tool to characterize boards and identify potential connectivity issues. Multi meter pass may not guarantee signal connectivity.
- ✓ Different fault analysis techniques – destructive and non-destructive can be employed to pin-point exact failure location on board.
- ✓ Careful examination of HDI stack up very important. Via connectivity failures can be eliminated by adherence to proper via **aspect ratio between each layer** in the stack up.
- ✓ Close interaction required with vendor to understand their capabilities and limitations.
