Die-Cracking Failure Analysis of QFN Packages in Manual Test Handler

MP Divakar, PhD
Stack Design Automation

2013 BiTS Workshop
March 3 - 6, 2013

- A series of failures were observed on a Digital Controller product packaged in 6x6mm 40-lead QFN during High Temperature Operating Life (HTOL) qualification tests run at two test houses, A (TH-A) and B (TH-B).
- Test program began at TH-B and then moved to TH-A.
- Failure modes ranged from loss of continuity to intermittency and opens.
- Packaged parts were tested on a Teradyne J750 mixed signal tester with manual handler.
- All parts were functional prior to the HTOL tests.

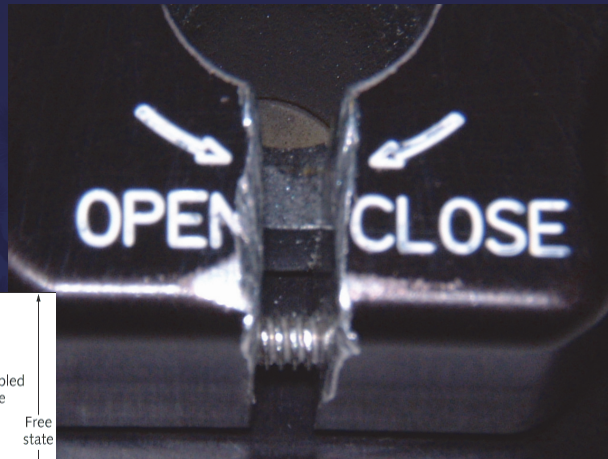
Observed Damage in Test Socket at TH-A

- Further, there were clear signs of over-torque in the socket handle at the slot where 'open' & 'close' positions are marked by prying it with a screw driver.
- It appeared that the test operators did this to address intermittency of spring pin contacts.
- It was postulated that the die cracking was induced by over-torque of the socket handle.

Socket Handle Wear (most likely caused by torquing with a metallic object such as a screw driver; the wear marks continue on to the plunge screw as circled above and hit the opposite wall of the plunge screw, shown in the previous page)

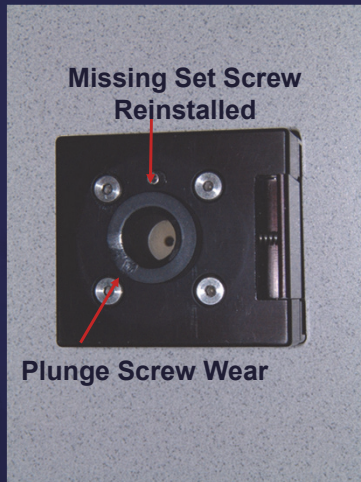
Observed Damage in Test Socket at TH-A

- This range is the difference in height between assembled vs. loaded states of the probe pins, shown next slide.
- Closer observation of the star-shaped socket lid handle and the plunge screw showed wear on the surfaces. It appeared that the test operators removed the set screw so that the socket handle traveled beyond the range its design for.

Socket Plunge Screw Wear and Missing Set Screw

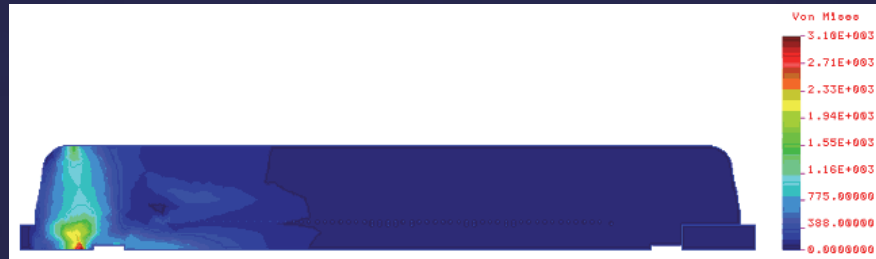
Stresses in Package at 0.030mm Loading

Stress contours in package using probe pin displacements (in MPa)

- Analytical and experimental investigations were conducted to establish the root cause of die cracking in a Digital Controller in 6x6 40-Lead QFN packages.
- Data gathered overwhelmingly point to overloading in the test sockets for further investigation.
- After examining the test sockets used at the two test labs, it was possible to map the damage locations and correlate them to the observed crack patterns in the failed units.
- Analytical models were proposed to simulate the overloading in test sockets based on the observed damages in the sockets.
- Results of finite element simulations using the proposed models indicate that the stresses in die surpass the tensile strength of Silicon using two separate approaches.

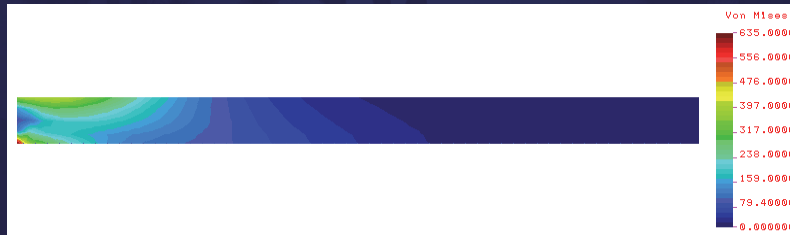
Stress contours in Silicon die using probe pin displacements (in MPa)
